CASE HISTORY

TEMPORARY PLUG TESTING

Lower Perforations Suspected of Producing Water

Location: Cabinda

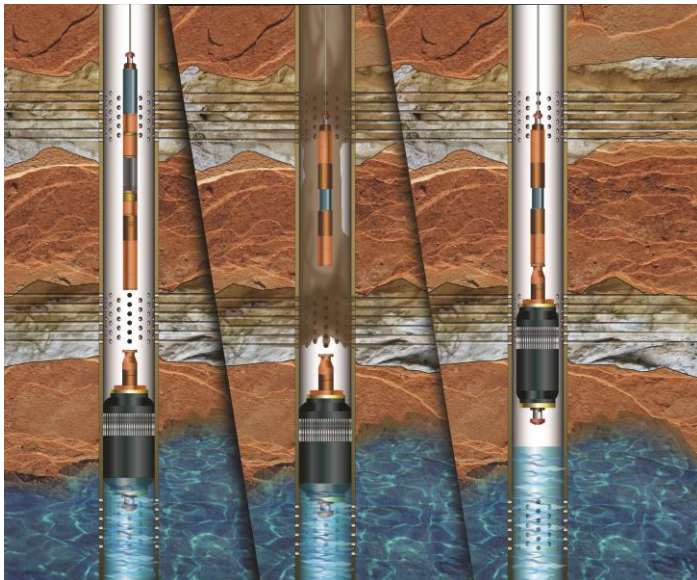
SlikPak Plus

CHALLENGES: A 10,800' oil completion with three sets of perforations, offshore Cabinda, was producing over 1,000 BPD with 90% water cut. PLT logs showed water source to be lower perforations

SOLUTION: TAM provided a SlikPak Plus, Inflatable Bridge Plug packer, to run on slickline and set above lower perforations. The well was placed on production test with only slight decrease in water cut, indicating no cement bond external of the casing between perforations. Subsequently, an inflatable packer was run on coiled tubing to squeeze cement into the lower perforations and repair the cement channel.

RESULTS AND BENEFIT: The remedial operations were successful in reducing water cut by 70%.
