CASE HISTORY

Inflatable Scab Liner

CASING FAILURE

Inflatable Scab Liner Set Across Corroded Casing

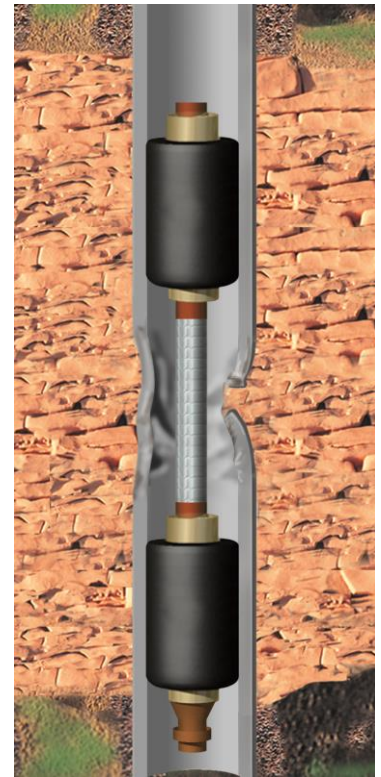
Inflatable Scab Liner

CHALLENGE: A 12,000 ft onshore oil producing field in central China had a corrosive water zone above the producing horizon causing casing failures and dumping water into the producing interval.

SOLUTION: TAM International ran a 5-9/16 in. OD inflatable straddle packer-scab liner with 300 ft of blank 3-1/2 in. tubing into the well using a 2-7/8 in. work string. The scab liner assembly was positioned across the corroded section of the 7 in. casing to isolate the water production. Once positioned, the lower packer was inflated and pull-tested to ensure proper inflation. Operators then inflated the upper packer and pressure tested the annulus to verify proper inflation.

RESULTS AND BENEFIT: The well was placed back on production at 214 BFPD with less than 10% water cut, resulting in a payout of less than 17 days.
