## CASE HISTORY

Well Intervention

### SUB SEA LEAKING P&A

Prior P&A Determined to have Slight Gas Bubbling from Inside Casing Stub

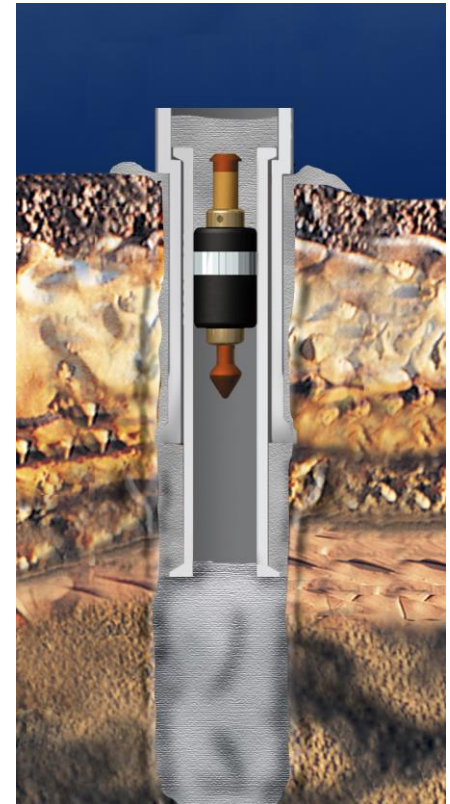
*Inflatable Packer*

**SOLUTION:** A 14-½" OD inflatable packer was run and stabbed into the casing stub. The packer was inflated and the well monitored for 24 hours using a down hole camera to assure that the gas bubbling had been stopped. A cement plug was placed above the Inflatable Bridge Plug to facilitate compliance with regulations. Monitoring of the well continued for 6 months and determined that no gas bubbling was occurring after the repair.
