CASE HISTORY

CAVERN REPAIR USING AN INFLATABLE BRIDGE PLUG

Storage Well Requires Repair of Casing Shoe Leak or New Casing String

Location: South Texas

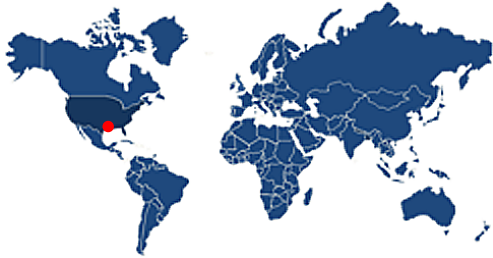
CHALLENGE: A salt dome dissolution cavern used for storage of natural gas developed a leak in the 16" casing set above the cavern. The cavern was emptied and taken out of service pending repair or plugging.

SOLUTION: An 11 in. OD inflatable bridge plug (IBP) was run through the 16 in. casing and set above the cavern inside 24 in. open hole. A sand and cement plug was placed above the IBP to prevent loss of cement into the cavern. Next, 13-3/8 in. casing was run to above the IBP and cemented to surface. The 13-3/8 in. float shoe and cement plug above the IBP were drilled out. The IBP retrieving tool was run to above the IBP, the sand plug washed off, and the IBP retrieved back through the new 13-3/8 in. casing.

RESULTS AND BENEFIT: The well was restored to service with an allowed increase in storage cavern pressure due to the increased depth of the new casing shoe. Restoring the well to service was achieved at a cost slightly greater than the estimated cost of plug and abandonment and eliminated the need to drill a new well typically costing in excess of \$2.5 million.
