CASE HISTORY

PosiFrac® Straddle System

Acid Stimulation Required for Plugged Screen/Gravel Pack

Location: Trinidad

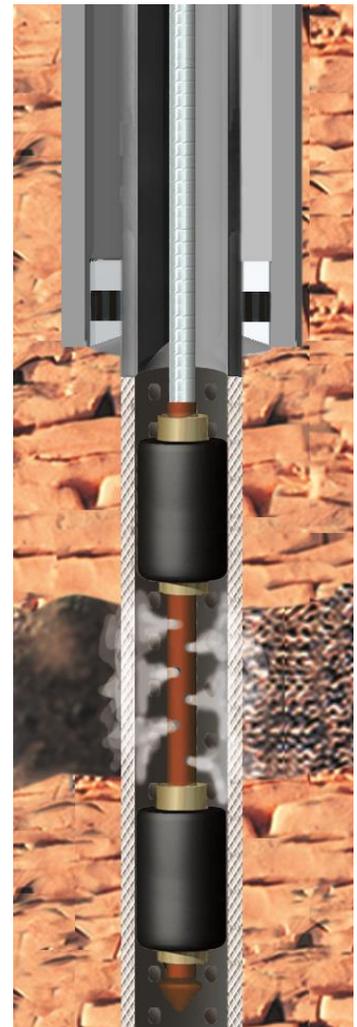
PosiFrac® Straddle System

SOLUTION: A 2-5/8 in. OD multi set inflatable straddle assembly (PosiFrac® Straddle System) was run on 1-3/4 in. coiled tubing and inflated inside the blank section of each 3-1/2 in. screen joint. One hundred gallons/ft of 7-1/2% HCL acid was pumped at matrix rates to remove the scale. The straddle tool was reset across each of 12 screen joints and the acid treatment repeated.
