CASE HISTORY

Inflatable Scab Liner

CASING FAILURE

Inflatable Scab Liner Set Across Corroded Casing

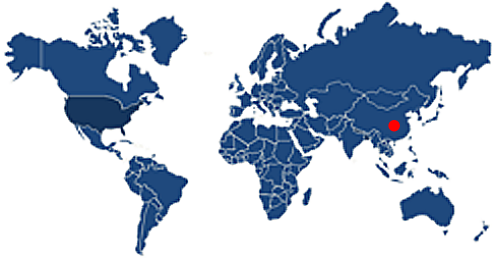
CHALLENGE: A 12,000 ft onshore oil producing field in central China had a corrosive water zone above the producing horizon causing casing failures and dumping water into the producing interval.

SOLUTION: TAM International ran a 5-9/16 in. OD inflatable straddle packer-scab liner with 300 ft of blank 3-1/2 in. tubing into the well using a 2-7/8 in. work string. The scab liner assembly was positioned across the corroded section of the 7 in. casing to isolate the water production. Once positioned, the lower packer was inflated and pull-tested to ensure proper inflation. Operators then inflated the upper packer and pressure tested the annulus to verify proper inflation.

RESULTS AND BENEFIT: The well was placed back on production at 214 BFPD with less than 10% water cut, resulting in a payout of less than 17 days.
