## CASE HISTORY

Well Intervention

### SUB SEA LEAKING P&A

Prior P&A Determined to have Slight Gas Bubbling from Inside Casing Stub

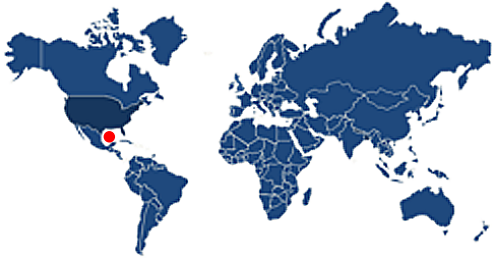
**CHALLENGE:** A GoM well previously plugged and abandoned was found to be bubbling on the sea floor by ROV camera monitoring. The 20 in. casing stub was located and cleaned out 100 ft below the sea floor for access.

**SOLUTION:** A 14-½" OD inflatable packer was run and stabbed into the casing stub. The packer was inflated and the well monitored for 24 hours using a down hole camera to assure that the gas bubbling had been stopped. A cement plug was placed above the Inflatable Bridge Plug to facilitate compliance with regulations. Monitoring of the well continued for 6 months and determined that no gas bubbling was occurring after the repair.
