## CASE HISTORY

Inflatable Bridge Plug

### BRIDGE PLUG APPLICATION: CASING REPAIR

Casing Failure Requires Repair

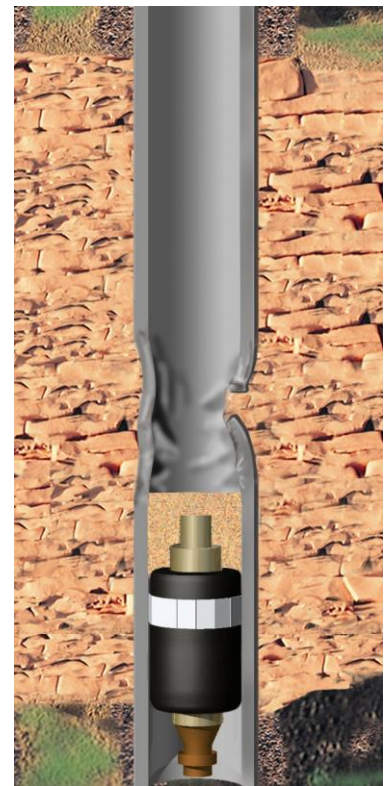
*Inflatable Bridge Plug*

**SOLUTION:** A 4 ¼ in. OD inflatable bridge plug (IBP) was run below the corroded section to prevent losses of trash and fluids into the injection zone and improve well control during the workover. The top 3,400 ft of 7 in. casing was cut and retrieved. A replacement 7 in. casing string was run with a pack off overshoot to latch onto and seal the 7 in. casing stub left sticking up. A stage cement job was performed above the overshoot with full cement returns to surface. The stage tool plugs were drilled out and pressure testing of the new casing and overshoot confirmed integrity. The IBP was retrieved and the well returned to service.
