CASE HISTORY

Well Intervention

Inflatable Scab Liner

Location: Cabinda, Angola

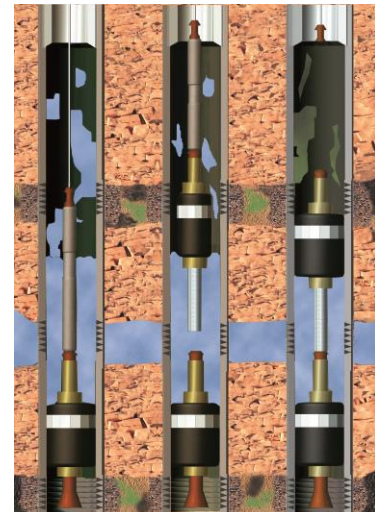
MIDDLE PERFORATIONS PRODUCING WATER

Run Scab Liner And Space Across Perforations To Be Isolated

Inflatable Scab Liner

SOLUTION: A 2.56 inch OD inflatable straddle packer-scab liner assembly was run using a slickline conveyed SlikPak™ inflation system. The lower packer was run and positioned between the middle and lower perforations. Blank spacer pipe was then run and latched into the lower packer. Then, the upper packer was run, latched into the spacer pipe, inflated and released the slickline running tools.

RESULTS AND BENEFIT: The middle perforations were isolated and the well was placed back on production. The well tested at 365 BFPD with less than 10% water cut resulting in payout of less than 20 days.
