CASE HISTORY

Well Intervention: Well Integrity Testing

Inflow Test at 16-in. Liner Lap to Detect a Possible Leak

TAM-J Multi-Set Inflatable Packer System

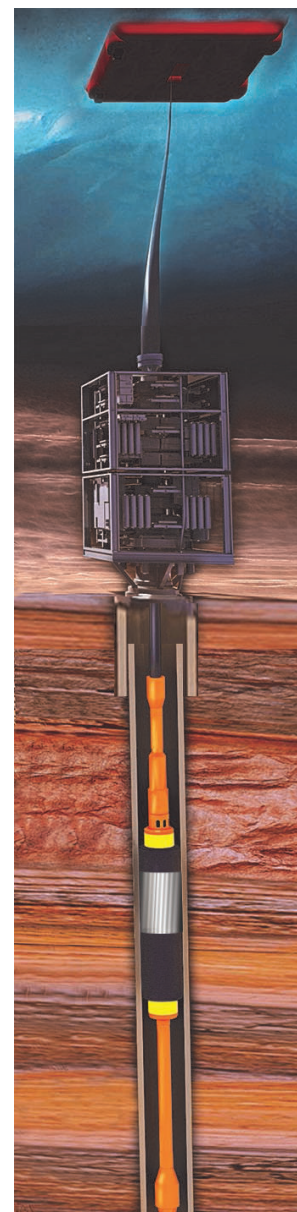
SOLUTION: TAM ran a 7-in. TAM-J Multi-Set Inflatable Packer with a 14-in. VE dual slat inflation element to isolate the zone above the liner lap.
